All I needed was a clutch – Part one

By Wes Fleming #87301

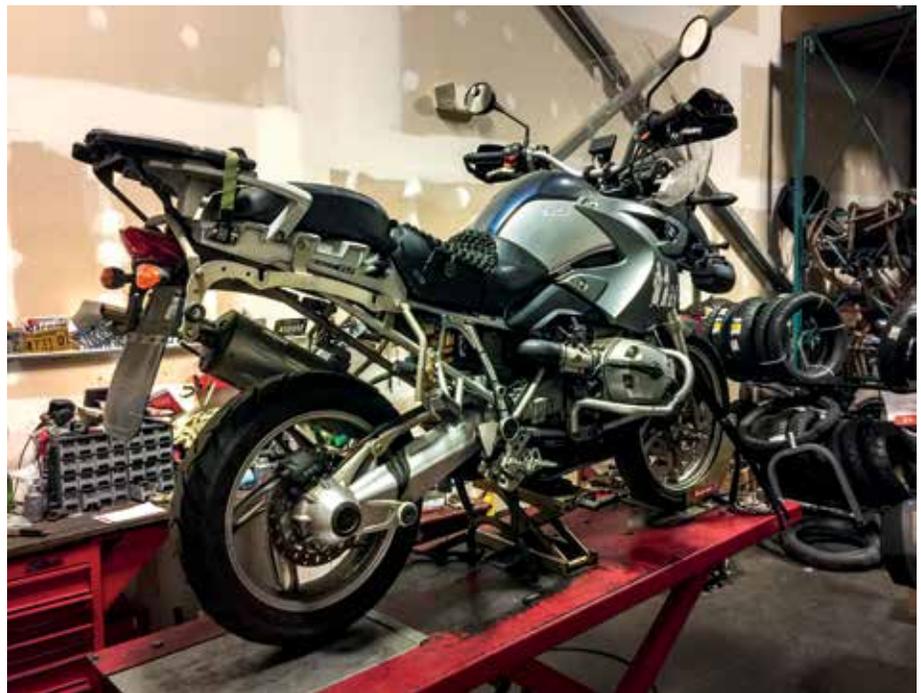
My 2005 R 1200 GS up on the lift before disassembly.

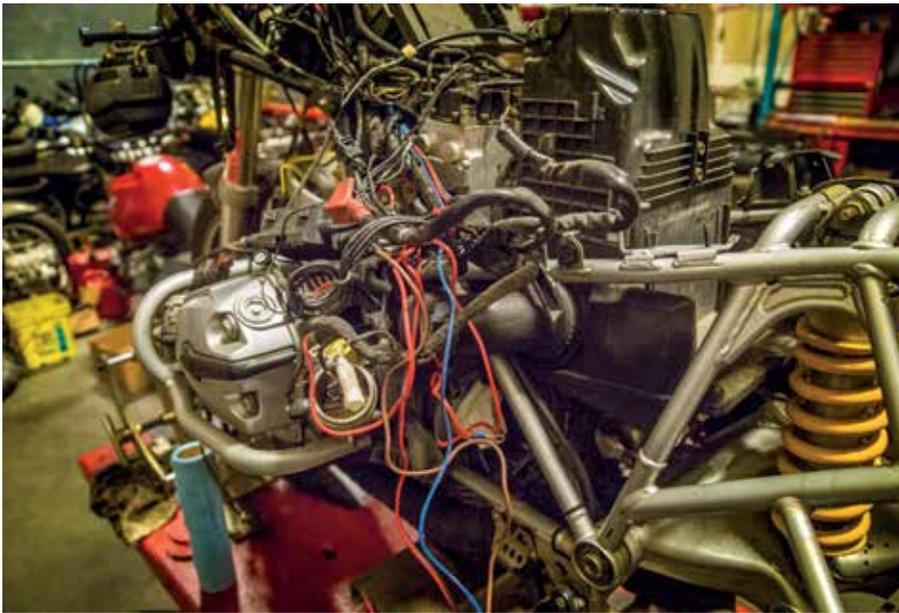
This rat's nest of wiring made things troublesome in the disassembly process. We disconnected, cleaned up and rerouted most of this during reassembly.

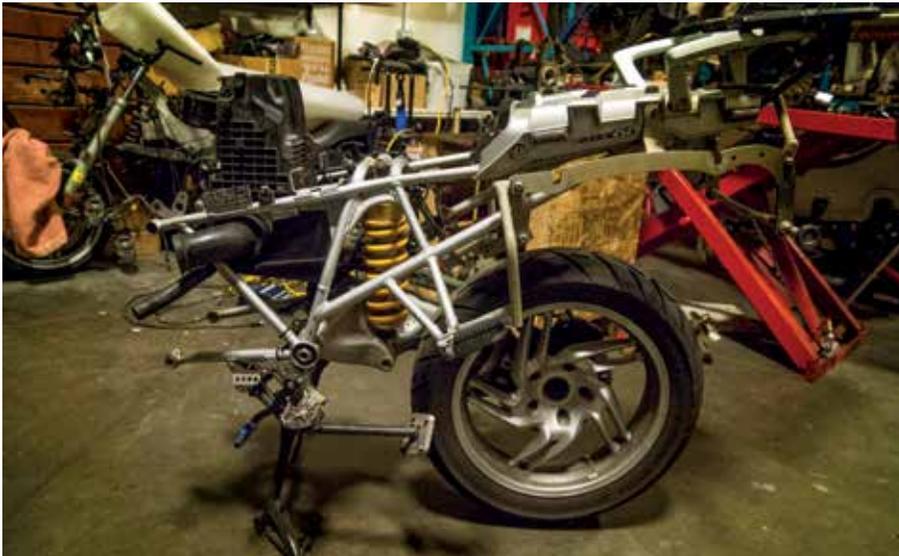
Leaving the rear wheel attached to the final drive allows for easy maneuvering of the entire rear section once it's disconnected.

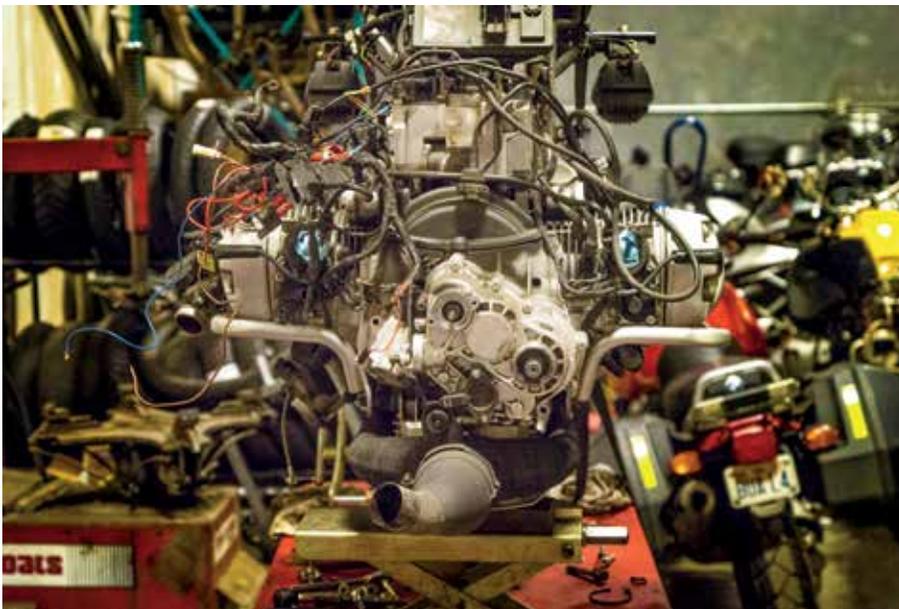
With the back half of the bike removed, it's possible to get at the transmission mounting bolts.

matter of removing seven bolts, popping the drive shaft off the transmission and rolling the back half of the motorcycle out of the way. It sounds a lot harder than it is, I know, but for the most part – wiring aside – I was able to accomplish the initial disassembly on my own, with just a bit of supervision and a few suggestions from the expert on hand.

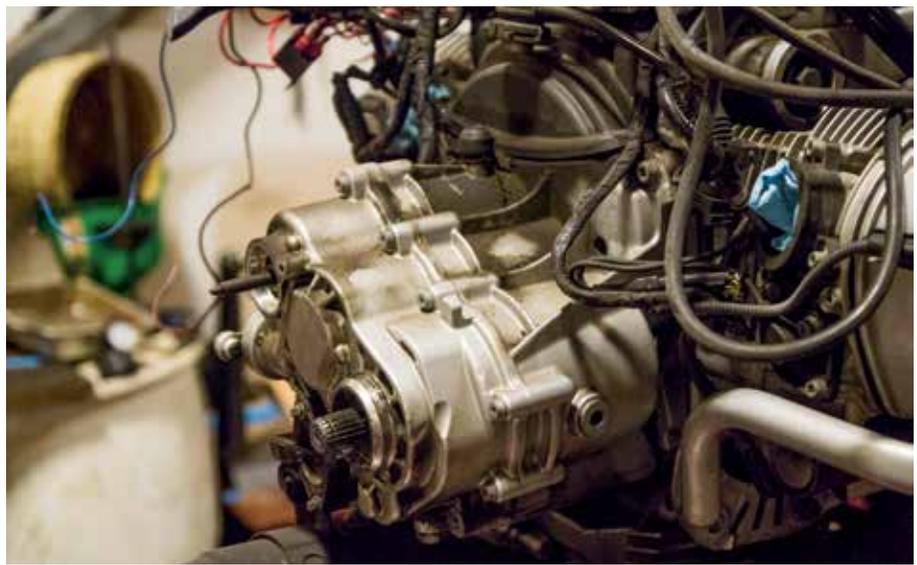
The transmission is dirt – dirtier than it should be, especially on top of the housing. This is an early indicator there may be problems inside the case. Note the pushrod extending from the top left of the transmission. The splined shaft at the bottom right of the housing is where the drive shaft connects to the final drive.

"Is it supposed to be that dirty in there?" I asked, after noting the grimy oil built up on both the back of the engine and inside the front of the transmission housing.

"No," George said, "No, it's not. I think you have a weepy seal."

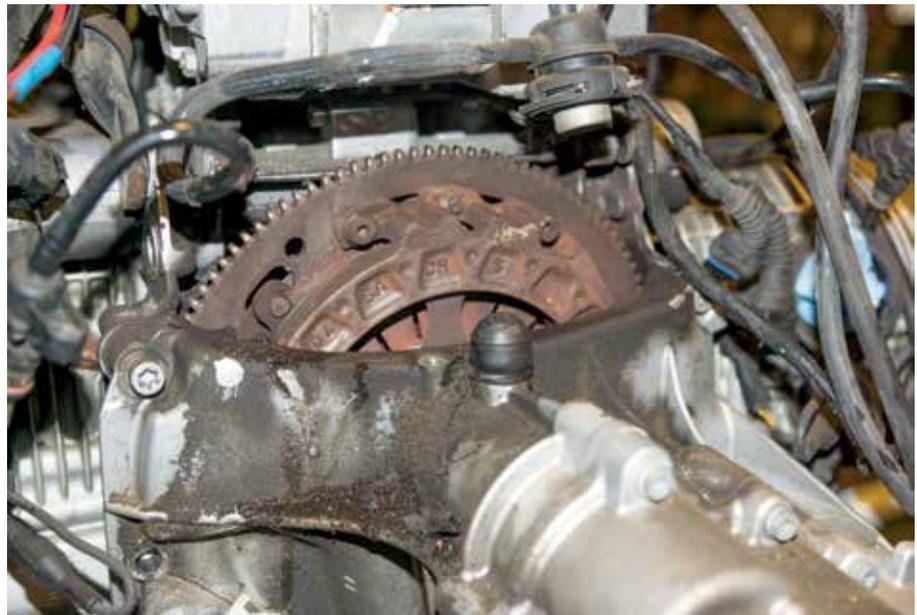
My first look at the rusted clutch components. While a certain amount of corrosion and wear – and possibly a bit of rust as well – is to be expected, this much rust is indicative of some hard water crossings during the bike's life.

transmission off – was rusty, stuck together splines. It shouldn't take much force to separate the transmission from the clutch assembly, but in my case it took two grown men wiggling the transmission and grunting with effort to separate them.

At this point, we realized it wasn't the clutch components being worn to the bottom of the spec range destroying my slave cylinders – it was the rusty splines making the slave cylinder work harder than it's supposed to. I could have kept replacing those \$232 slave cylinders until the clutch components really were too thin and it wouldn't have fixed the problem.

Why they were rusty escapes us both. I have, on occasion, stored the motorcycle outdoors for extended periods of time, but that shouldn't matter. The only thing either of us could come up with is that one of the bike's two previous owners must have undertaken a water crossing, somehow allowing water to get in there. Since I've had the bike since January 2011, I've never taken it through more than a couple of inches of water, so I'm sure it wasn't me. Standing in the shop with the transmission on the lift, it didn't matter what started the rust. We identified the source of my clutch woes and had the parts to address the problem...

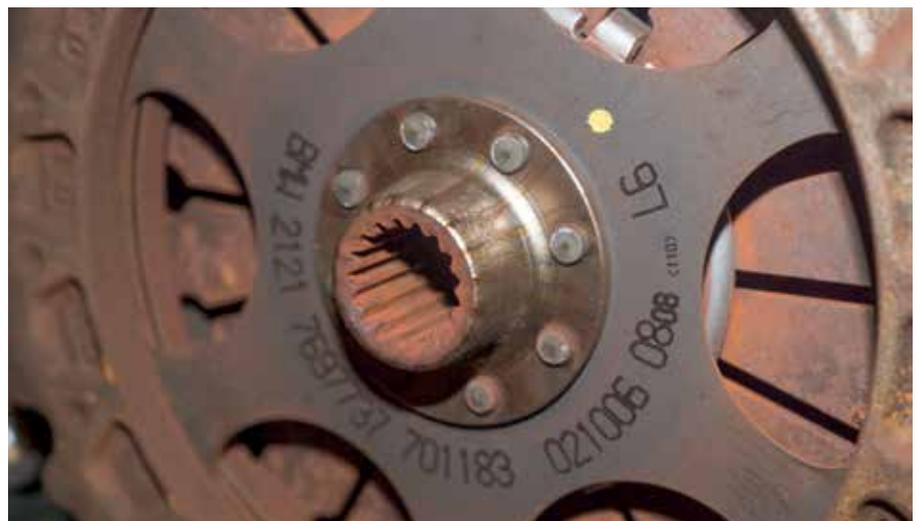
The rusty splines of the old clutch plate (aka friction disc).

Since I had to replace the clutch plate anyway, there was no point in cleaning the splines on the female end of the assembly. We did, however, have to take a wire brush to the splines on the input shaft and make sure we got off as much rust as possible.

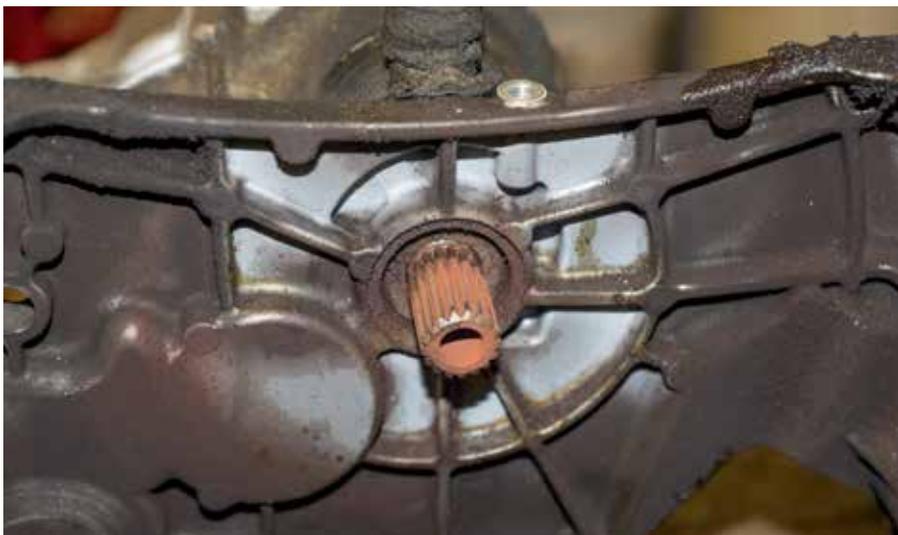
Rust on the transmission input shaft splines.

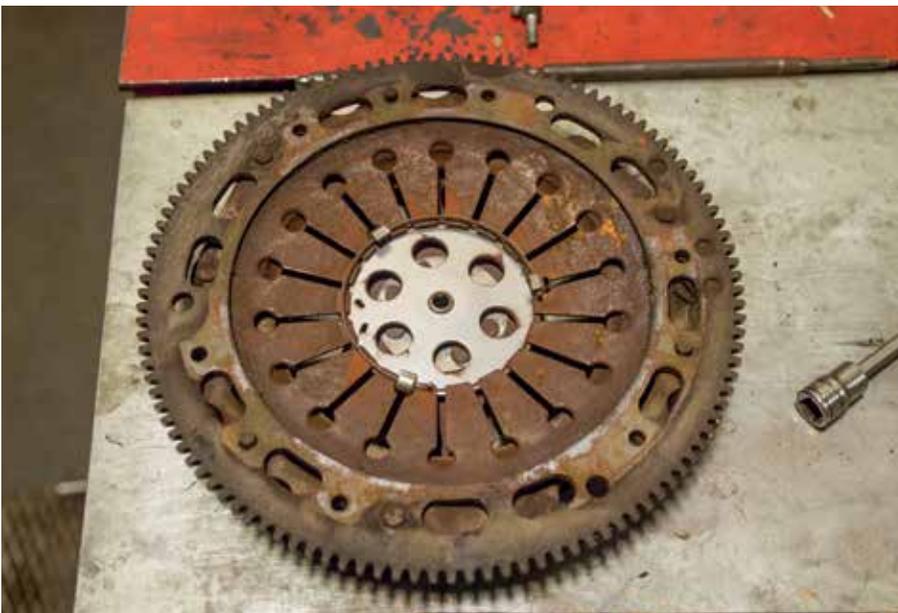
The rusty clutch spring plate that's part of the pressure plate assembly, which engages with the teeth of the starter motor. The protruding pins near the teeth are rivets that hold flat springs onto the other side of the assembly.

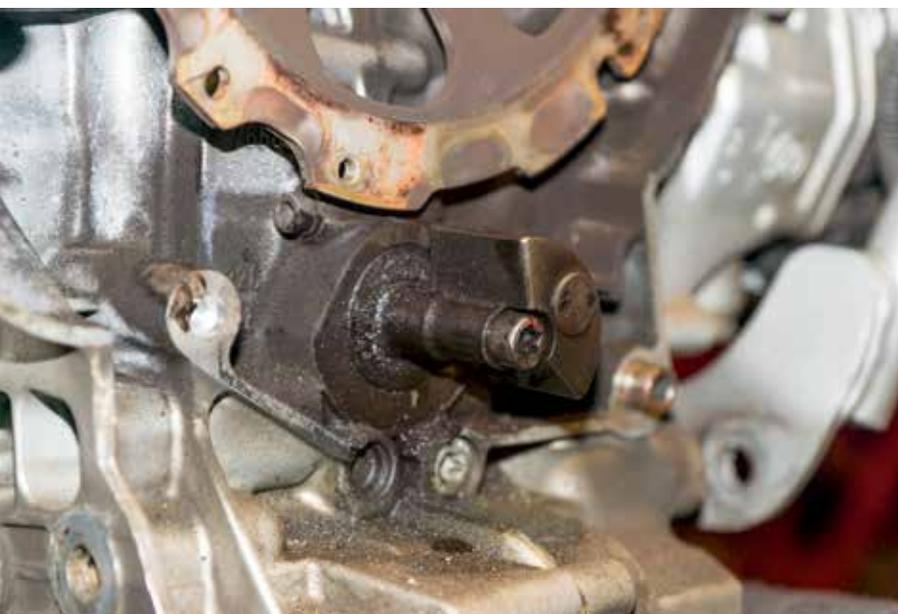
Engine oil being forced past the counterbalance shaft seal created a slimy, gloppy mess inside the space between the engine and the transmission.

That particular seal is what keeps the oil inside the engine from getting out around what BMW calls the compensating shaft. Most of us would refer to it as the counterbalance shaft, because the counterbalance weight is bolted onto the end of it. After noting the failing seal on the counterbalance shaft, we studied the transmission more closely, wiping away a bit of the grime. George decided he didn't like the looks of the seals on either end of the input shaft (aka drive shaft), and those would have to be replaced as well. The problem was, we didn't have any of those three seals in stock. Transmission input shaft seals are a common item to replace during a clutch job, so normally we would have them, but George had done a clutch on a customer's R 1200 RT a few days before and hadn't had a chance to replace them yet. The seal on the counterbalance shaft doesn't commonly fail, so that was simply an unexpected thing

both are quite a bit less concerning than a leaking seal, but when the weepy seal in question requires cracking the bike in half to repair, the prudent course of action is to replace it before moving any further.

A quick call to the dealer closest to my house, Morton's BMW in Fredericksburg, Virginia, got the counterbalance seal on order with an overnight delivery. They had it waiting for me, along with the other two seals, as soon as they opened on Friday morning. I returned to the shop, faced

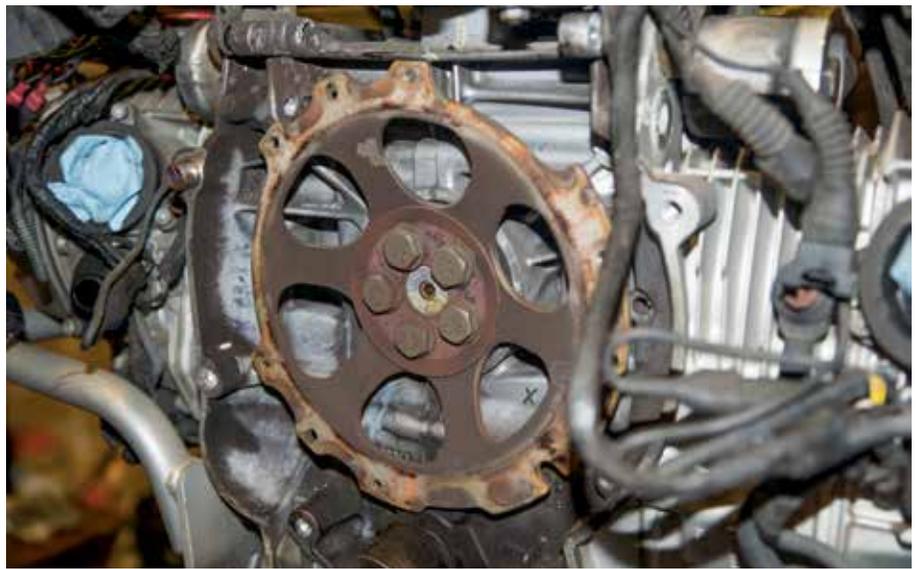
The flywheel – which BMW calls the clutch housing. It doesn't generally need replacement when installing a new clutch.
